PROPERTY CONDITION ASSESSMENT
OF
WORLD TRADE CENTER PORTFOLIO

FOUR WORLD TRADE CENTER

Property #4
Merritt & Harris, Inc. Project Number 20-251E

Re: Due Diligence Physical Condition Survey
World Trade Center
New York, New York

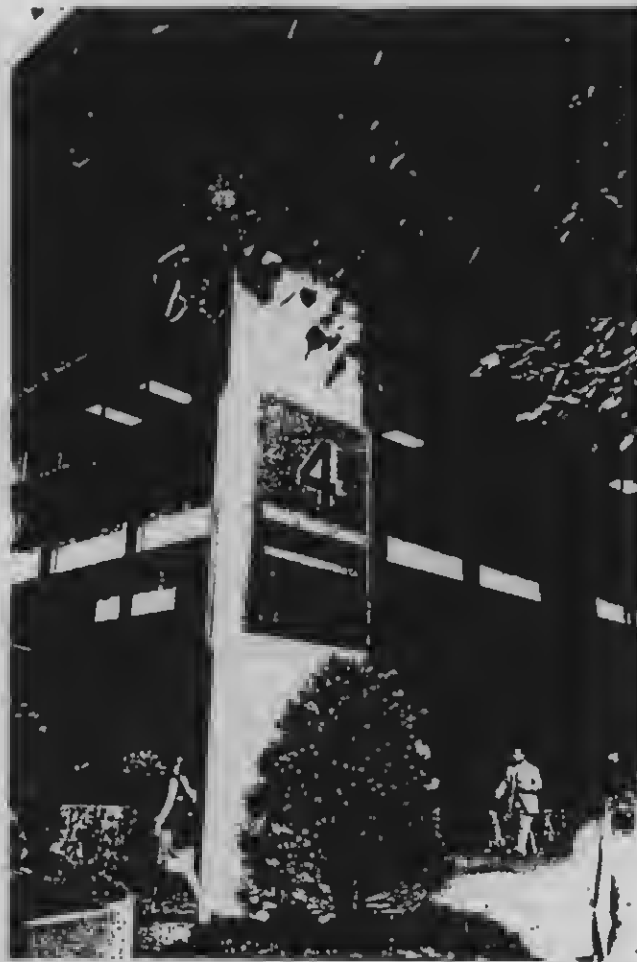
Photograph 1

Entrance pylon
at Church Street
Plaza entry

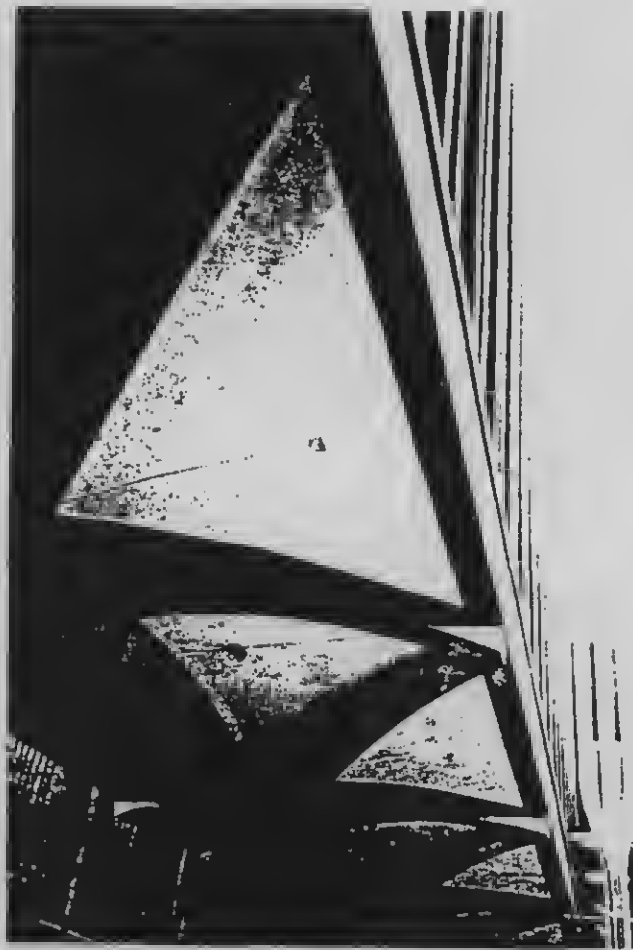
Photograph 6

Framing of
cantilever below
4th floor deck

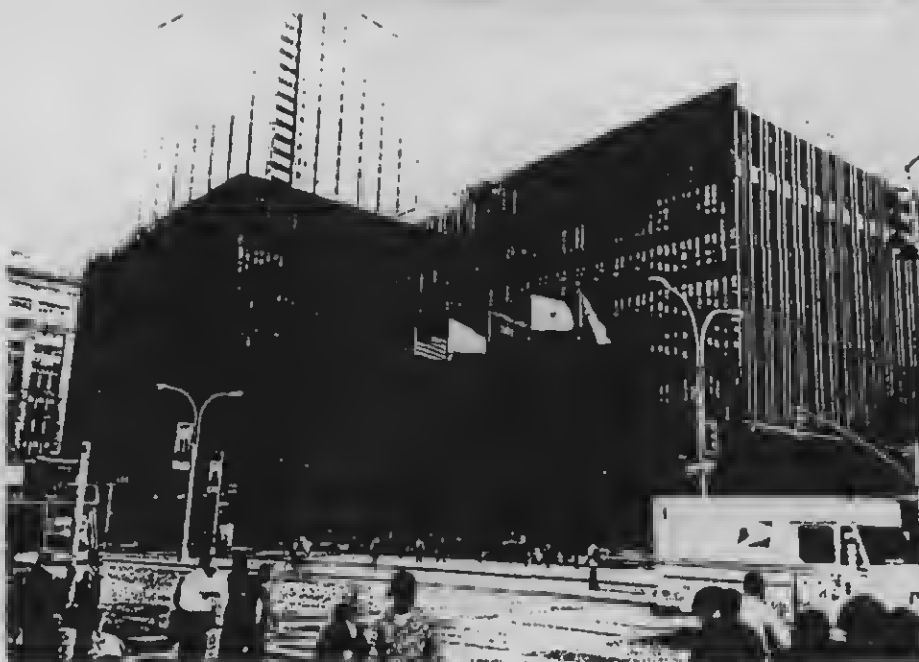
Photograph 7

Aluminum
cladding conceals
steel truss to
support
cantilever at 4th
floor overhang

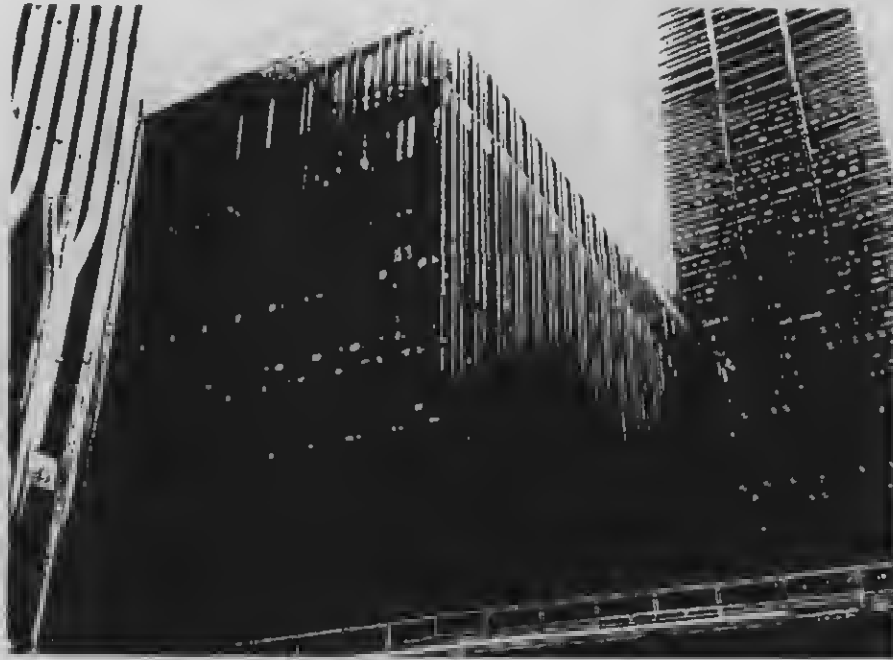
Photograph 10

Supplementary
stair tower
added in 1995-96
to serve trading
room on 8th
floor

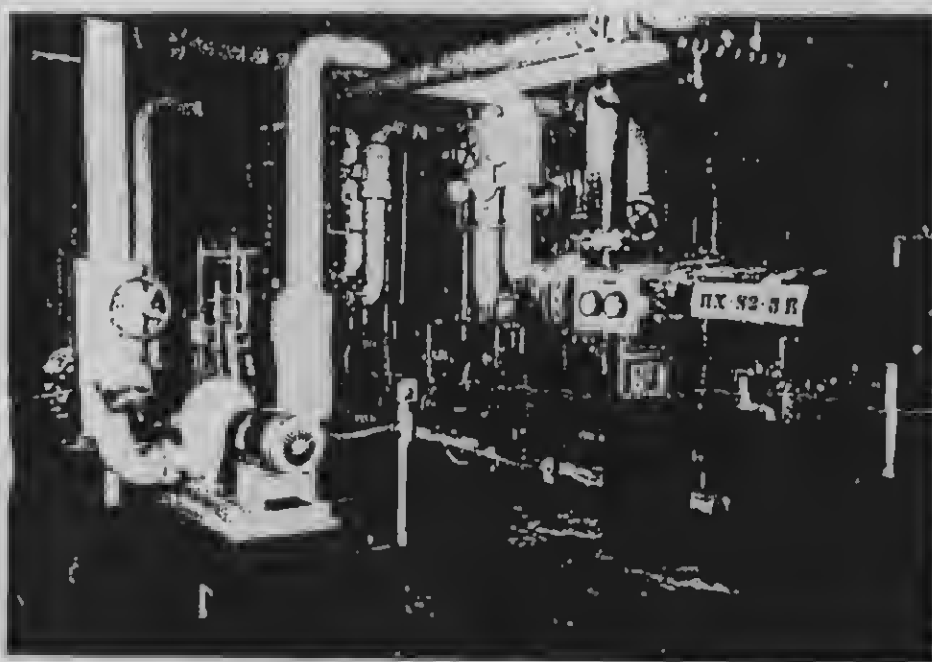
Photograph M5

Condenser water
supply and
return lines for
tenant
supplementary
air conditioning

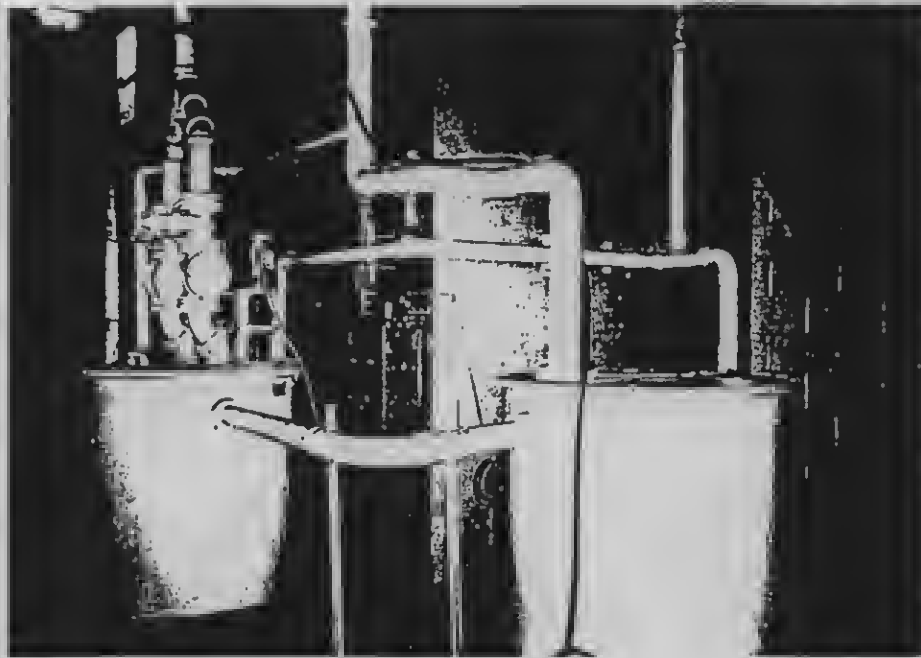
Photograph M6

Heat exchanger
and circulating
pump for heating
hot water

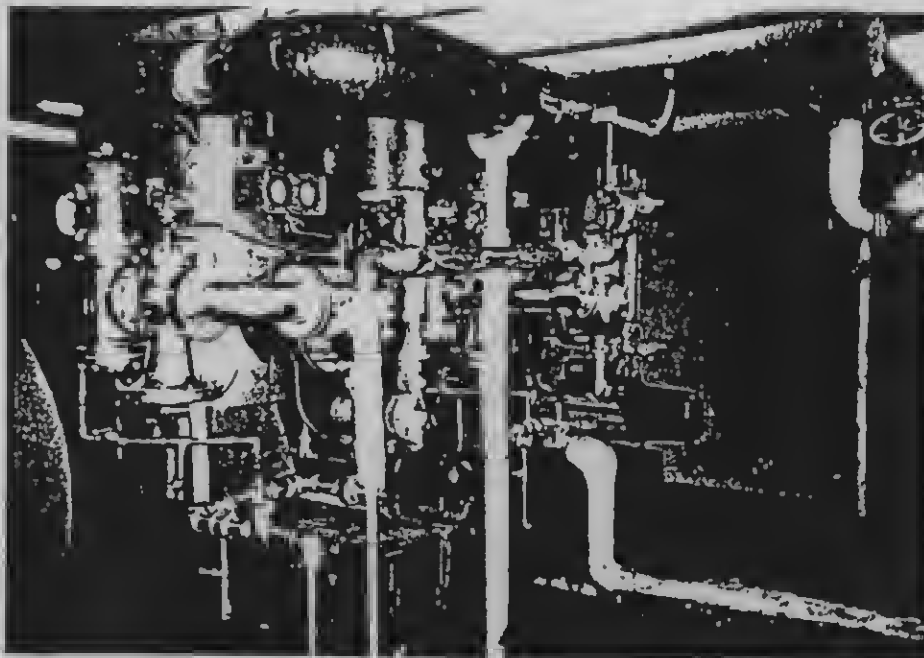
Photograph M7

Ejectors and
tanks located in
the B1
mechanical room

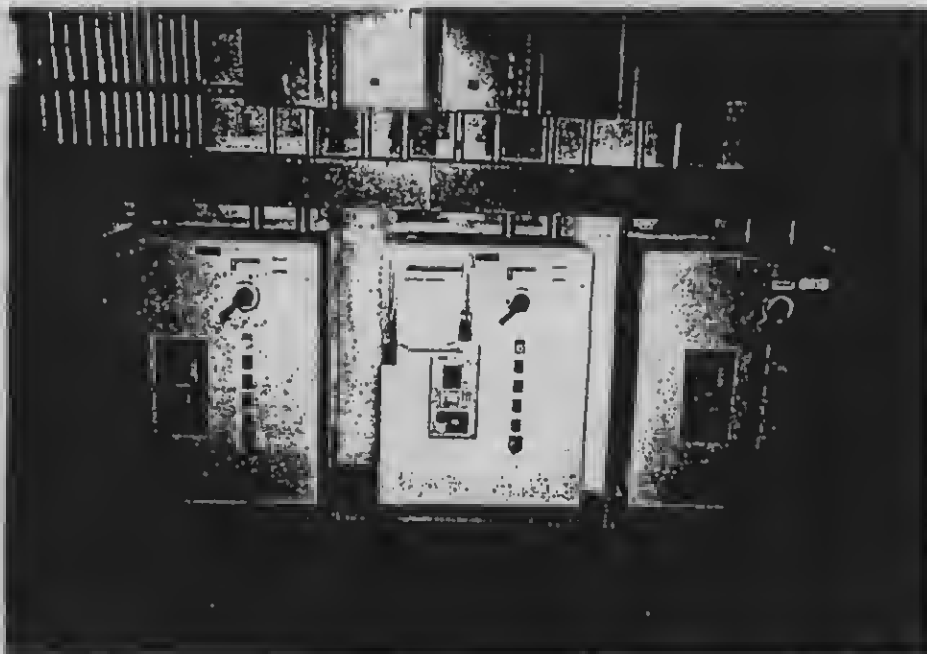
Photograph M11

Booster fire
pump located in
the 9th floor
mechanical room
